PLASTIC HEAT SEAL PINS

Dicronite® used to increase production output by over 28%

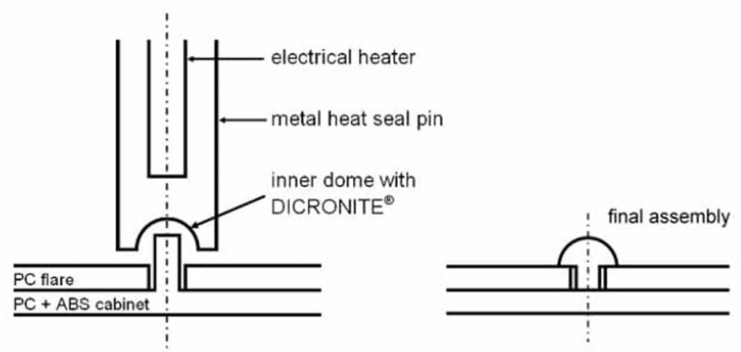
In hopes of finding a solution that further reduced net cost, downtime, and increased output, the manufacturer decided to test Dicronite®. The goal of the test was to see if Dicronite® could increase production at least 25% over current volume while not changing pin cavity geometry to ensure conformance to design specifications. Dicronite® was applied to the cavity and sliding surfaces of the pins in place of the Teflon coating.
