DICRONITE®

Plastic Molding Heat Seal Pins

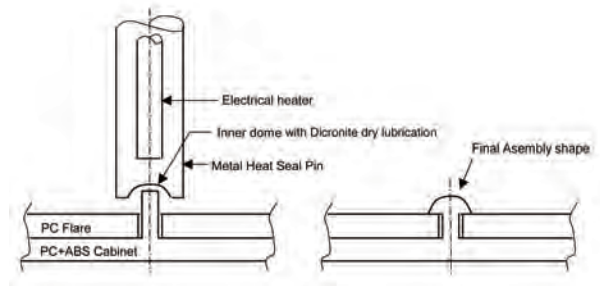
Dicronite dry lubrication is being applied to the cavity and sliding surfaces of the pins. As a result:

- A major manufacturer of LCD televisions is using a heat-sealed pin system to bond two pieces of the front cabinet panel. There are 10-15 heat seal pins per jig depending on panel size.
- The manufacturer encountered severe sticking of the resin to the heat seal pin resulting in waste and stoppage. Production was less than 50% of the goal.
- A Teflon coating was applied to attempt to improve the situation. With the Teflon coating:
 - Production increased but to only 60% of the production goal.
 - 2 stoppages per shift were required to manually remove waste resin and apply an additional mold release agent to the pins.
 - The Teflon coating required complete repolishing and reapplication every 2 to 3 weeks, at a cost of \$7,000.

- Operate at or above a temperature of 185°C continuously.
- Increase production at least 25% over current situation.
- Not change pin cavity geometry to ensure specifications.
- Net cost reduction relative to Teflon coating and downtime.

- Production throughput has increased by over 28% and scrap rates have decreased.
- Production stoppages and secondary release agent usage have been eliminated.
- Higher operating temperatures (>185°C) are being used, allowing production staff to further optimize production.
- Coating operating costs were reduced by greater than 50%.
