ENGINE PERFORMANCE IMPROVEMENT

Dicronite® was proven to improve engine performance

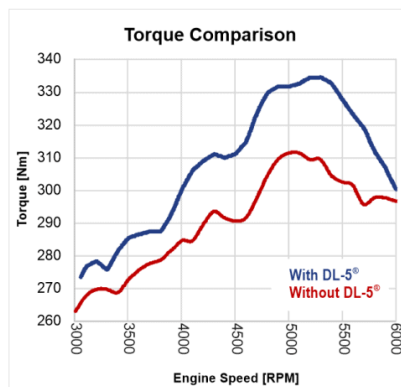
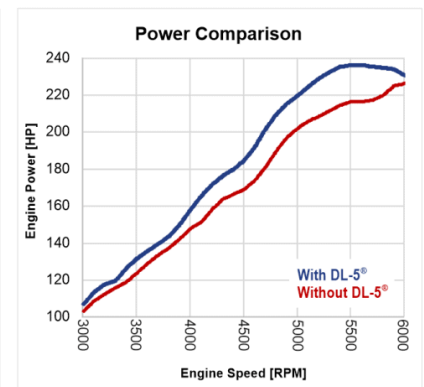
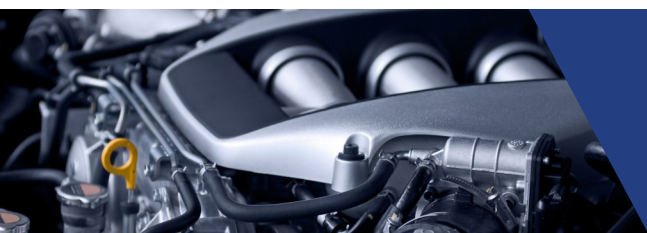
The engine was tested with a dynamometer and disassembled. The crankshaft, journal & main bearings, timing chain, rods, wrist pins, rings, piston skirts and valve assemblies were coated with Dicronite®. After reassembly, the engine was tested again.

- 9% increase in peak torque
- 10% increase in peak horsepower
- 3% decrease in exhaust temperature
